August 26, 2026

## **I. OUR INVESTIGATION**

SEMCORP Hungary Kft.

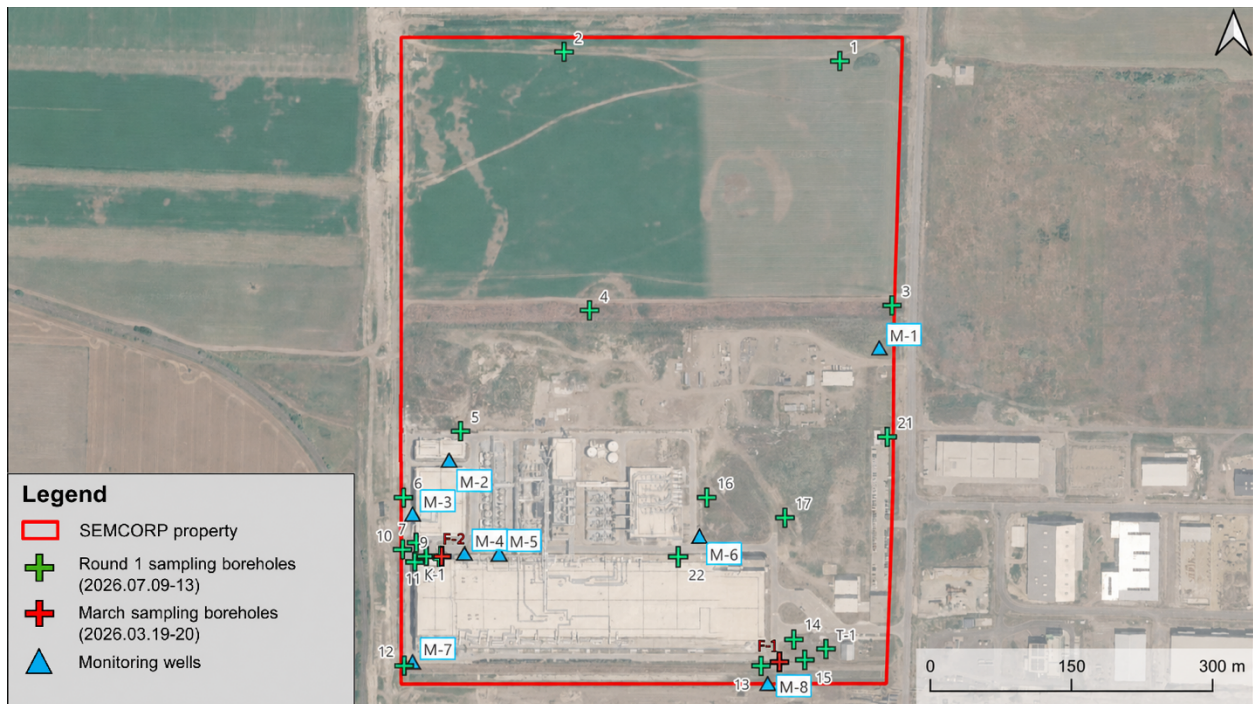
Fig. 1. SEMCORP property map showing locations of monitoring wells and Round 1 sampling boreholes.

- The first round involved sampling groundwater and soil from **20 new boreholes** and the existing **8 monitoring wells** by **4 independent accredited laboratories**. An accredited expert selected the borehole locations in order to delineate the scope of any contamination, particularly around F-1 and F-2. The 20 boreholes were drilled and soil samples collected under expert supervision during early July, and each of the 4 labs dispatched qualified technicians to separately collect groundwater samples from all 28 points during July 15-21. Below is a map showing these 28 points.

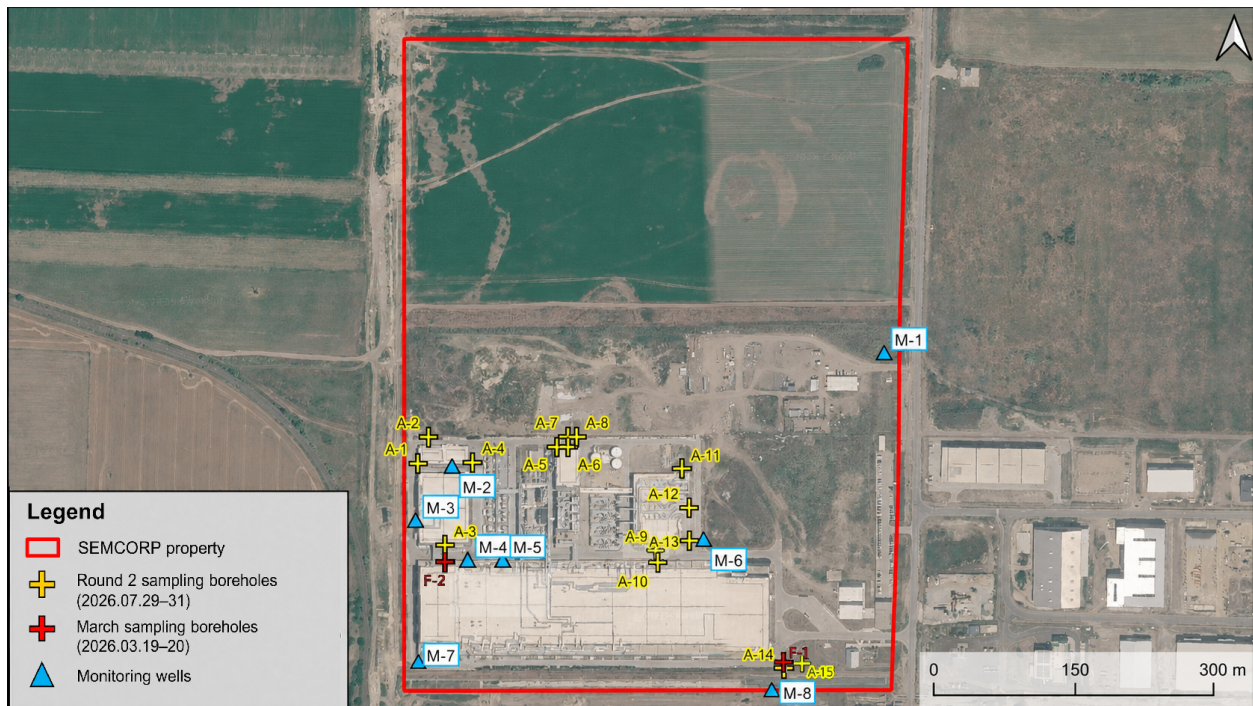
Fig. 2. SEMCORP property map showing locations of monitoring wells and Round 2 sampling boreholes.

- Early results from the first round of testing showed remarkable consistency across laboratories. We proceeded with a second round of confirmatory sampling from an **additional 15 new boreholes** by Eurofins, Hungary's largest laboratory for subsurface media testing. These 15 boreholes were specifically placed in areas that may be trafficked by materials containing aluminum oxides, which are the only raw materials in our process that contain any of the metallic elements detected in high concentrations in March. Drilling and sampling took place during July 29-31. Below is a map showing the additional 15 sampling points.
